Photographic Feature

Glacial hazard assessment at Tsho Rolpa, Rolwaling, Central Nepal

John M. Reynolds

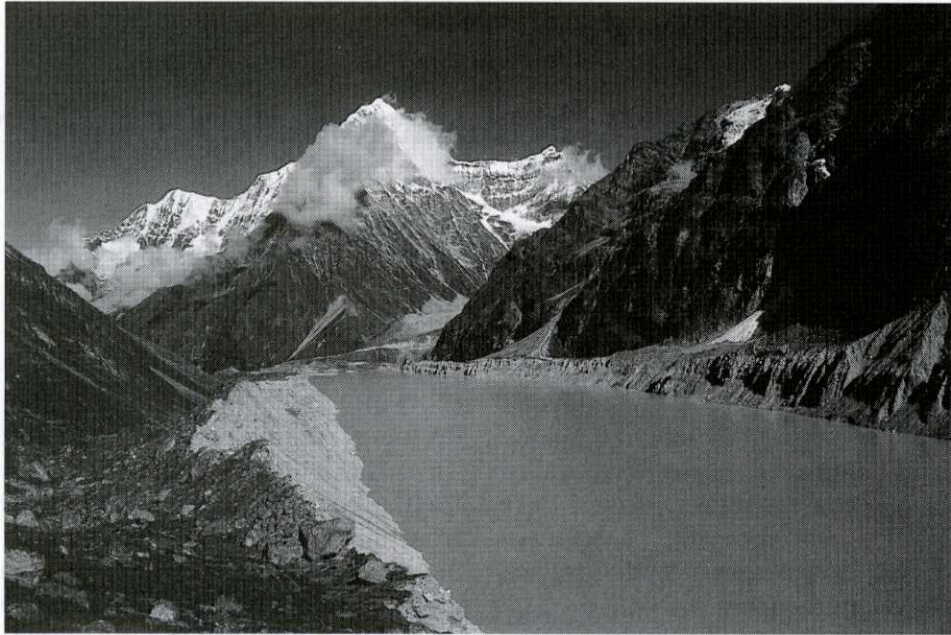
Fig. 2. Tsho Rolpa glacial lake viewed towards the northwest. The eroding lateral moraine is over 80 m high (photographed in September 1994).

(Fig. 1) and immediately south of Gauri Sankar (7146 m). The lake (Fig. 2) is about 3.5 km long by 0.5 km wide and is up to 135 m deep. It is fed by Trakarding Glacier (Fig. 3) to the southeast which is itself a composite glacier supplied by several glaciers from among the peaks to the east and south east of Tsoboje (6689 m). The north-western end of the lake is dammed by a terminal moraine complex (Fig. 4). This is up to 150 m high and is partly cored by stagnant glacier ice of unknown thickness. The lake currently holds about 80 million cubic metres of water; it is thought that a Glacier Lake Outburst Flood could occur at some time in the near future with a potential volume of up to 30 million cubic metres of water.

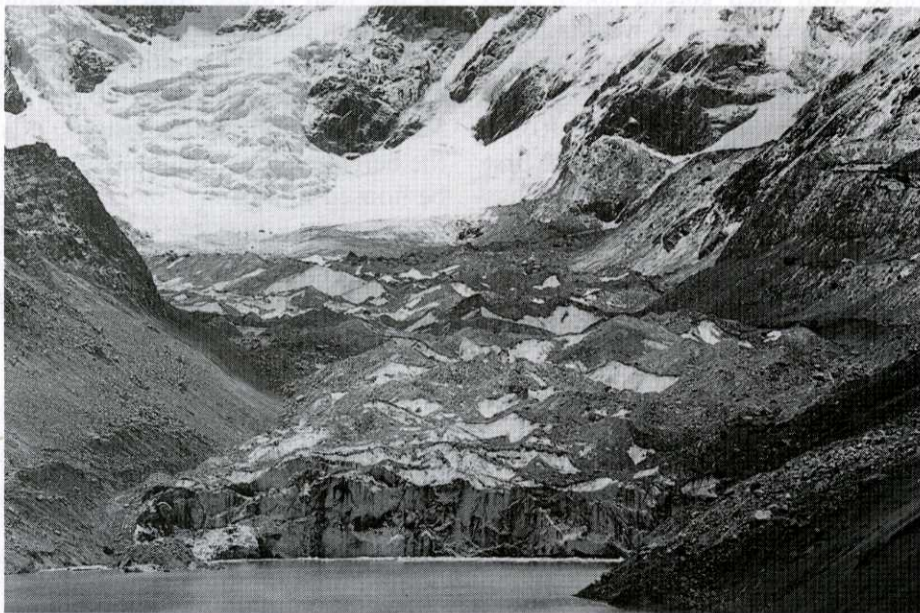
Fig. 3. Snout of Trakarding Glacier viewed to the southeast. The terminal ice cliff is estimated at around 40 m high. The ice cliff calves most days during the summer months and the ensuing splash wave can travel the length of the lake. The largest wave recorded to date is over 1.3 m high at the terminal moraine (photographed in September 1997).

through the outer flank of the moraine, indicated that the moraine was deteriorating structurally. Furthermore, increased ice avalanche activity from the ice cliff at Trakarding Glacier, coupled with greater avalanche magnitudes, observed between 1994 and 1997, were also cause for concern. Displacement waves, caused by ice avalanches from the terminal ice cliff at Trakarding Glacier, were observed in 1997 to reach in excess of 1.3 m in amplitude at the terminal moraine. Conse-

quently, the risk due to waves overtopping the moraine dam and causing regressive erosion on the distal side was also increasing with time.

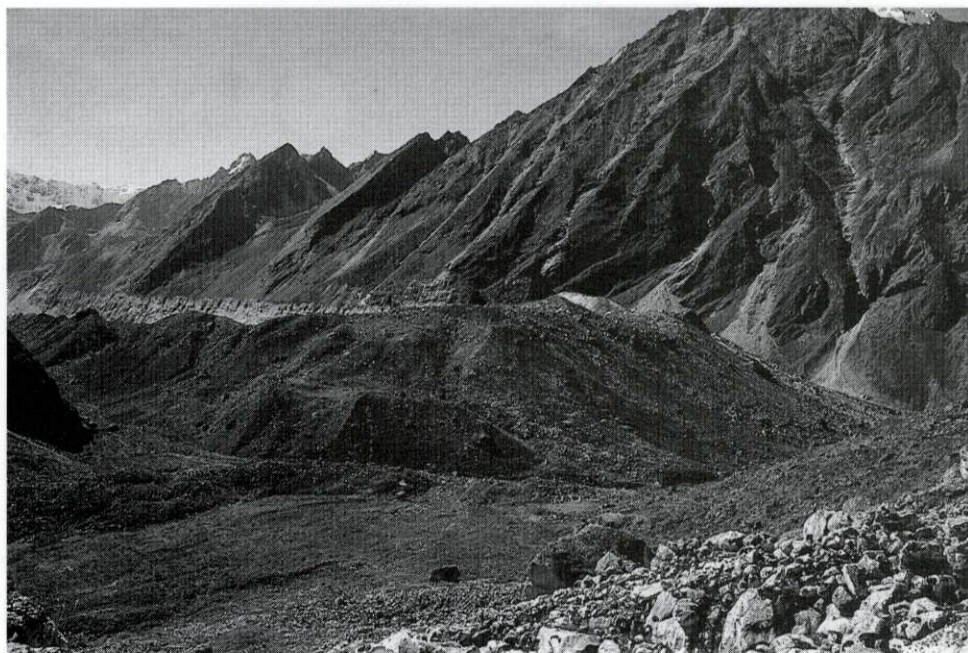
Fig. 4. The terminal moraine of Tsho Rolpa viewed from the Ripimo Shar moraine complex (photographed in September 1994).

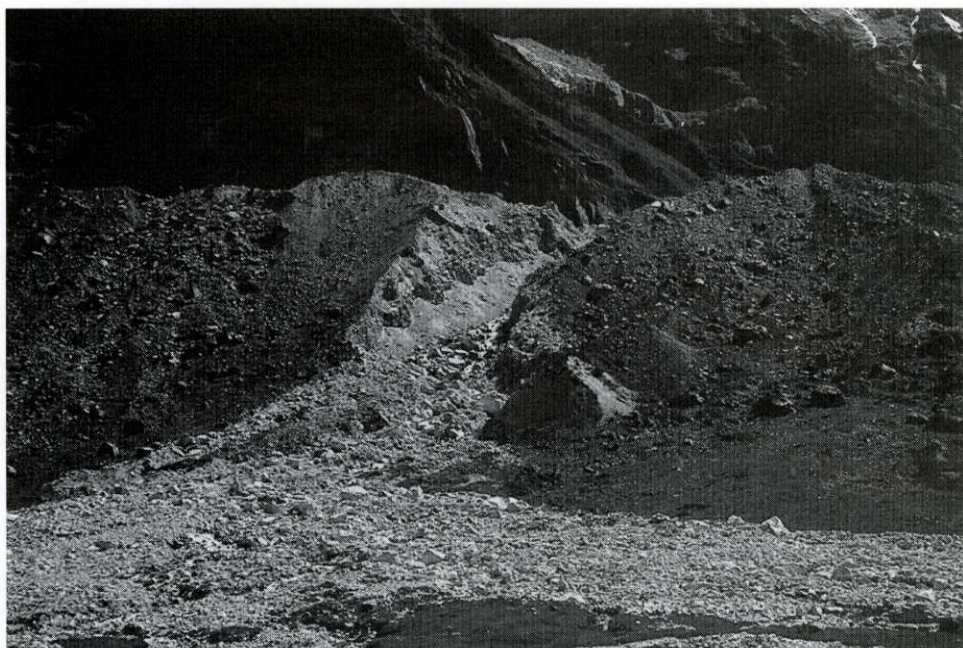
Following three very warm days in July 1991, an ice avalanche fell into Chubung lake causing it to burst through its terminal moraine dam at the southwestern end of Ripimo Shar Glacier (Fig. 1) and drain completely. The breach, estimated as being 15 m deep and

20 m wide, is shown in Figs 5 and 6. As is typical of GLOF breaches, a significant debris fan formed immediately downstream of the breach in which the coarser debris load was deposited. The water and finer material travelled downstream past the village of Na, where the flood killed some livestock and destroyed one bridge, and continued through the village of Beding. The flood wave killed one person, destroyed three flour mills and several potato fields, and caused great alarm amongst the inhabitants.

Fig. 5. The Chubung breach of July 1991. Some of the boulders in the foreground fan deposit weigh in excess of 400 tonnes (photographed in September 1994).

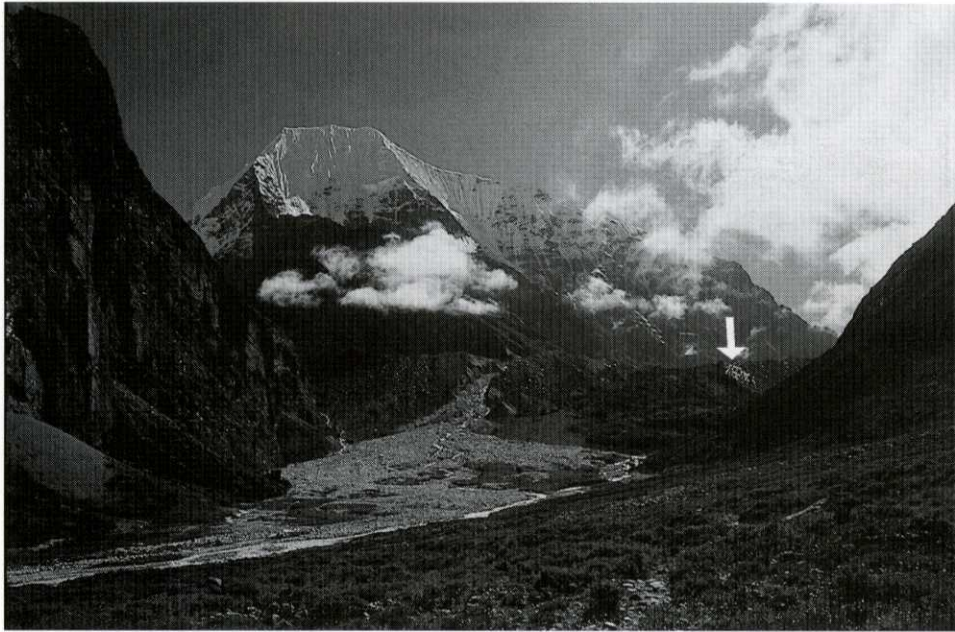
Fig. 6. The view towards the eastern end of Rolwaling Valley from Na, showing the Chubung breach and fan deposits, and the spillway from Tsho Rolpa (arrowed). The base of this valley lies at an altitude of 4200 m and the main snow-capped peak shown is Tsoboje (6689 m). This peak also marks the boundary with Tibet (China) (photographed in September 1994).

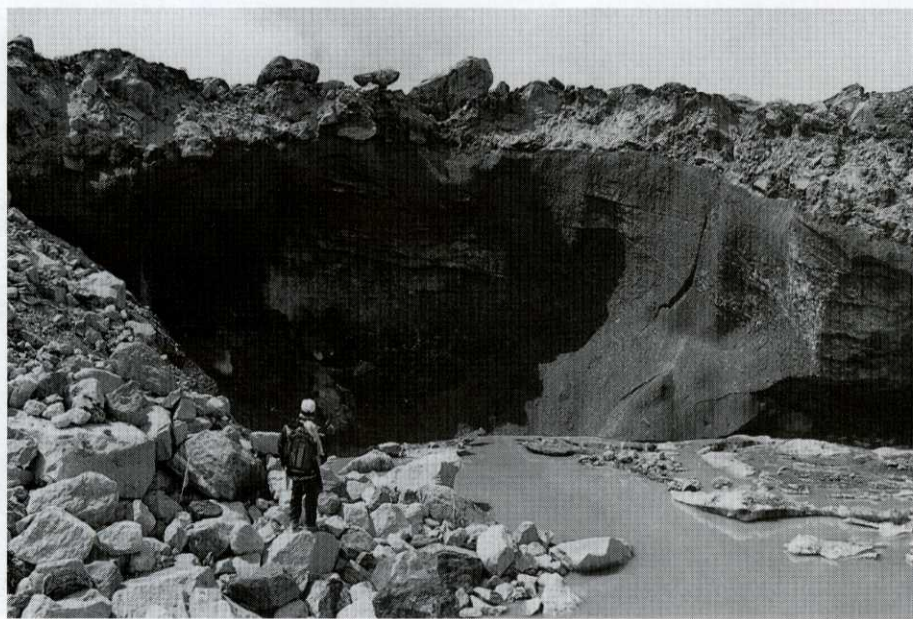
Fig. 7. This 34 m wide thermokarst hole in the northwestern terminal moraine had developed by May 1997 from a 3 m diameter depression that had been observed in October 1996. The resultant ice cliff shown here was 11 m high and the pond was over 3 m deep. Between May and September 1997 this feature had doubled in size and had reduced the moraine dam width by a further 30 m (photographed in May 1997).

A revised proposal for remediation of Tsho Rolpa was submitted by His Majesty's Government of Nepal to the Dutch Government in December 1997. Funding worth \$2.9 million was granted in March 1998 to implement a remediation programme for completion by July 2000. This will involve the construction of a 4 m

deep artificial spillway to lower the lake level by 3–4 m. An additional phase of remediation, currently under negotiation, will be needed to lower the lake by 15–20 m below its present level before the potential hazard can be considered to have been successfully remediated.
